**BRIDGE CONDITION REPORT
STRUCTURE NUMBER 027-0040**

FINAL REPORT

FAP ROUTE 798
SECTION 107BR-1
FORD COUNTY
P-93-064-02

ILLINOIS ROUTE 115
OVER DRAINAGE DITCH

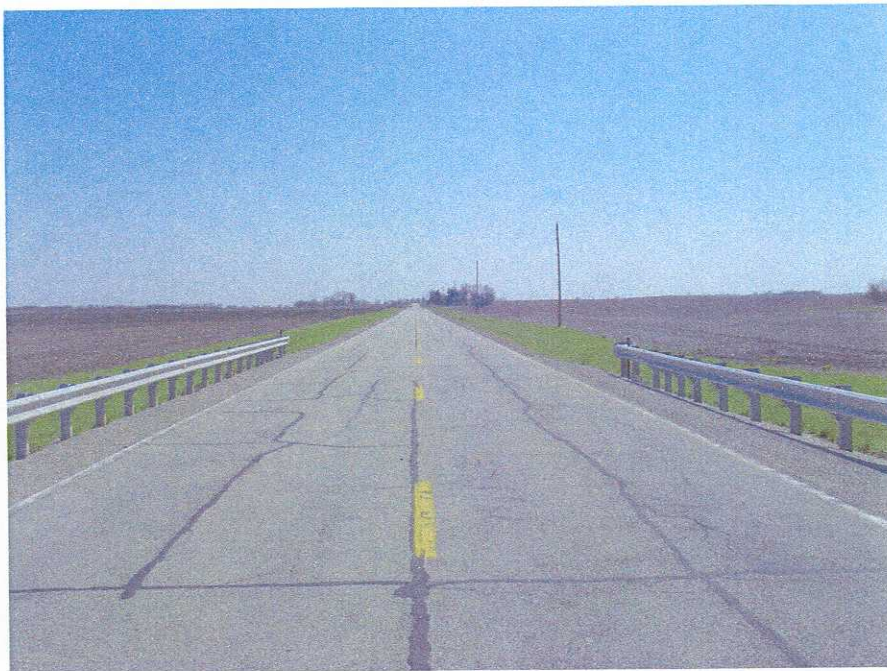
LOOKING SOUTH FROM SOUTH ABUTMENT

The approach roadway is in fair condition. Reflective cracks in the bituminous surface are forming in the pavement. Slight rutting is occurring in the wheel lanes along the overlay. The reflective cracks have been recently sealed. Bituminous patching/filling along the south abutment indicates the approach pavement is failing.

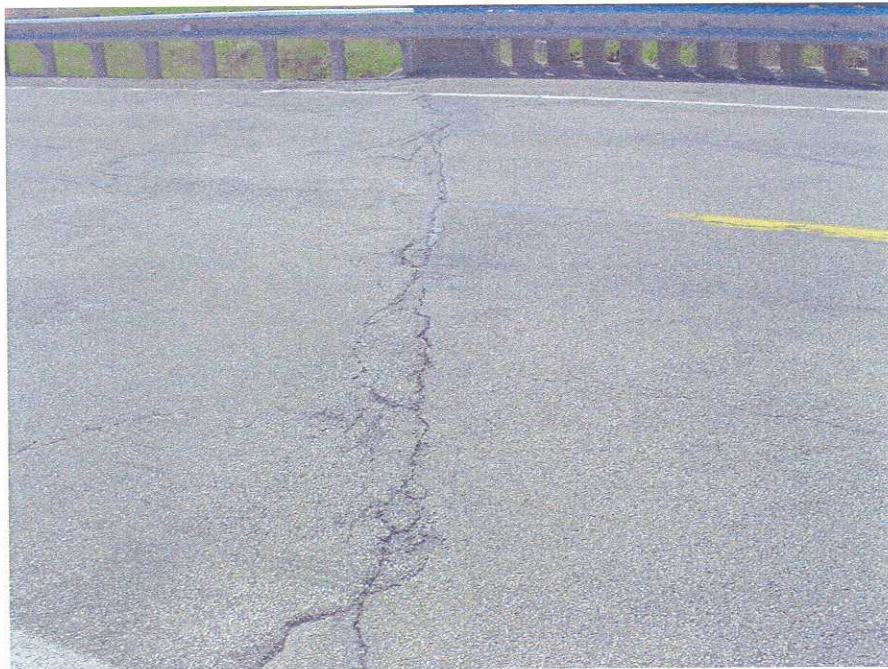
SOUTH EXPANSION JOINT (looking west)

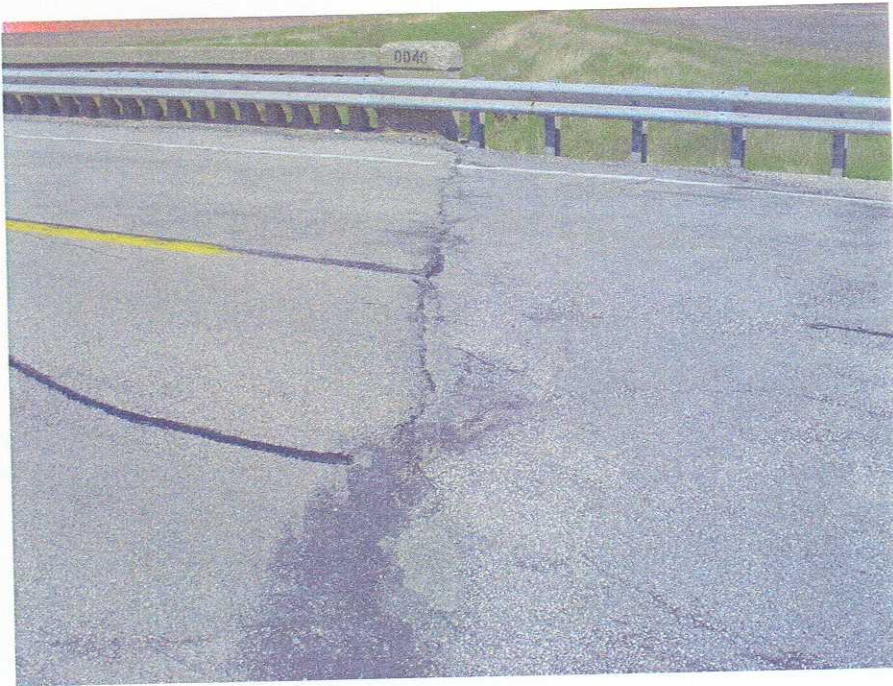
SOUTH EXPANSION JOINT (looking east)

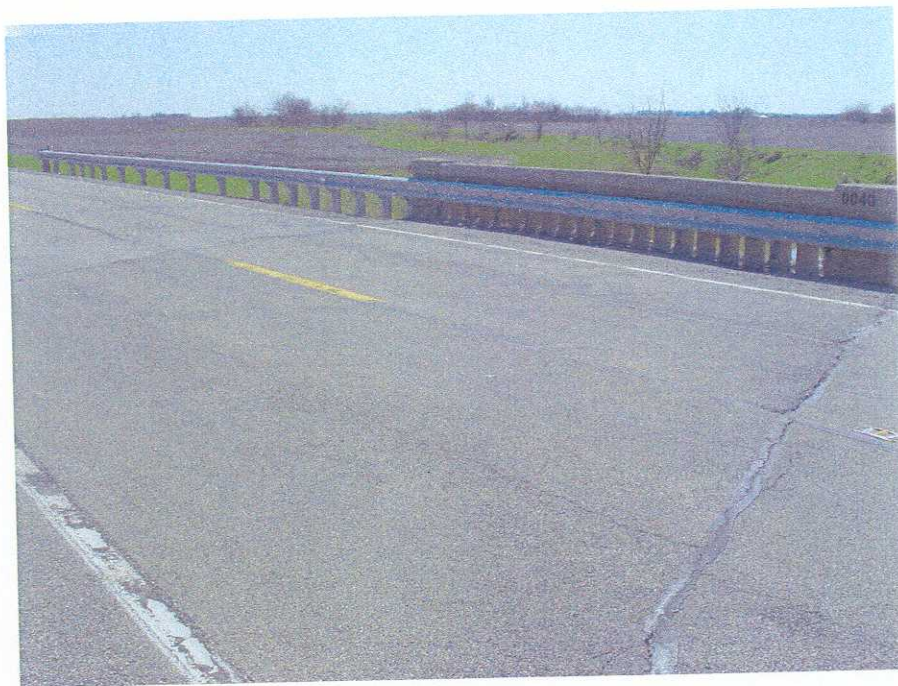
DECK SURFACE (overall) LOOKING SOUTHWEST

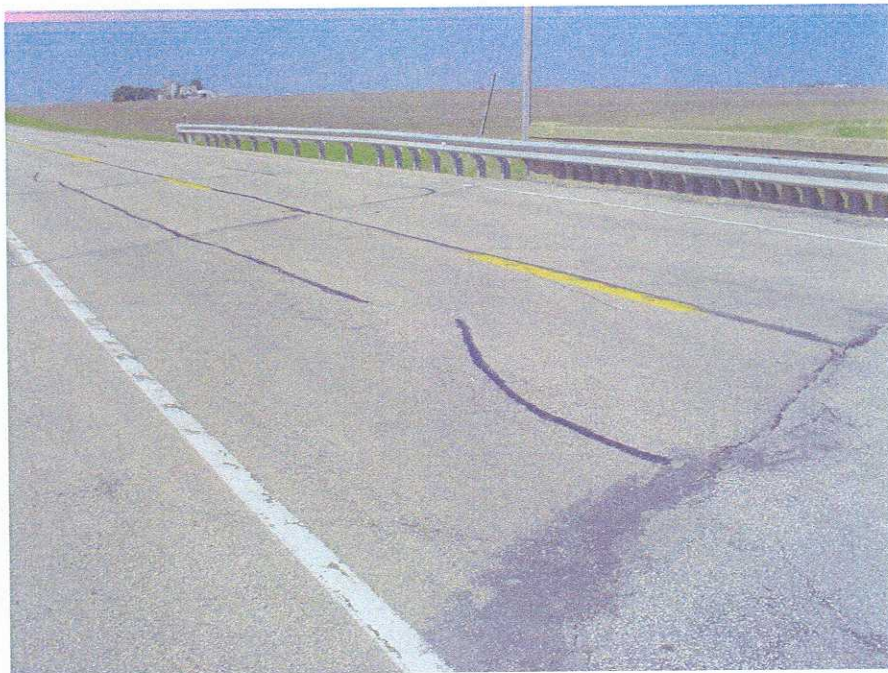
DECK SURFACE (overall) LOOKING NORTHEAST

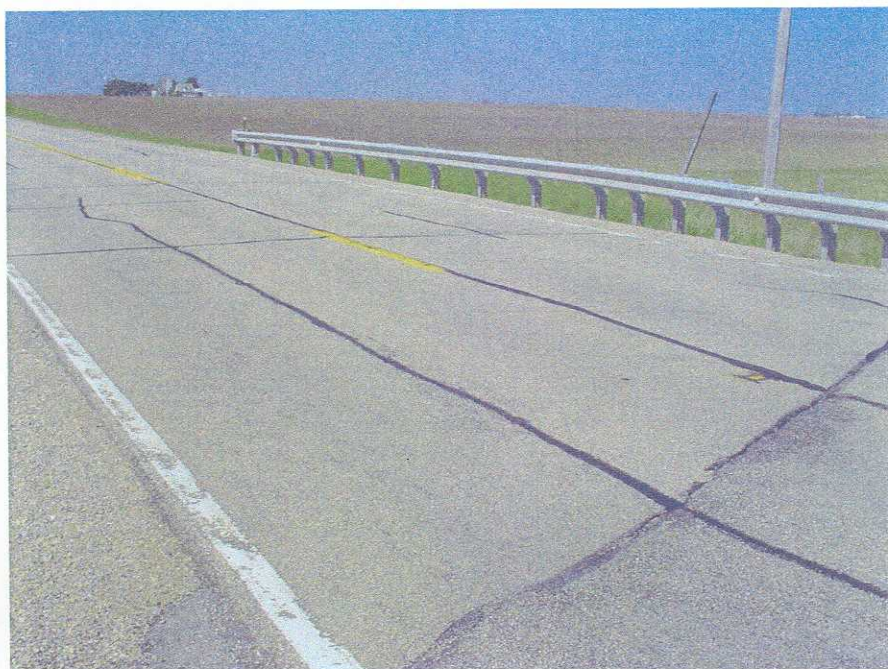
NORTH APPROACH PAVEMENT

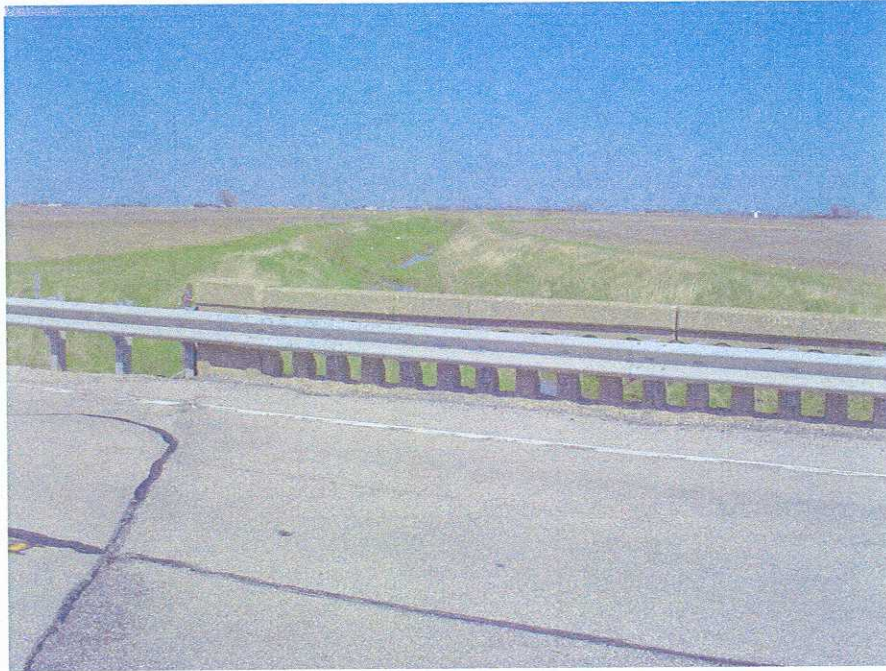
NORTH END OF EAST BRIDGE RAIL

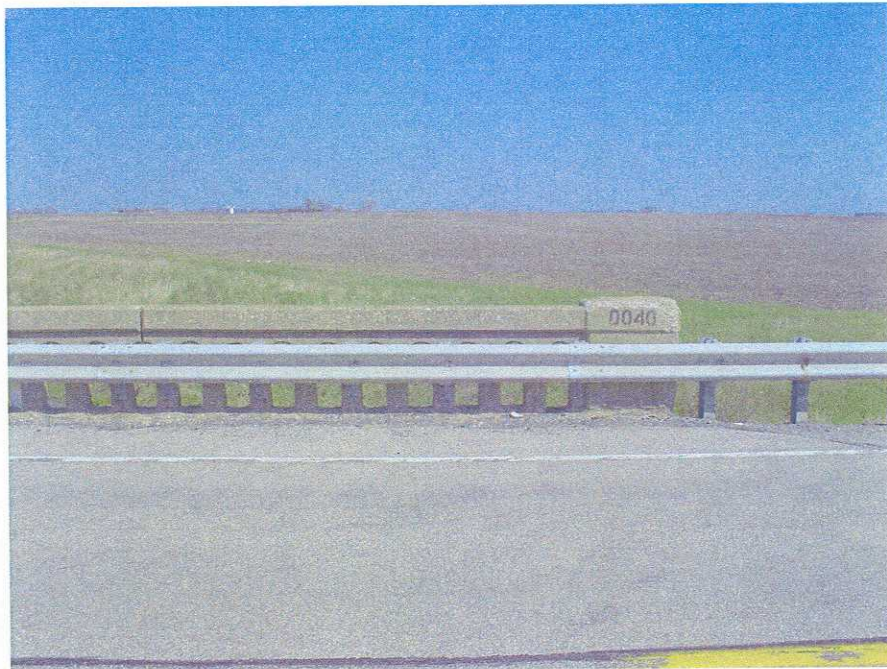
SOUTH END OF EAST BRIDGE RAIL

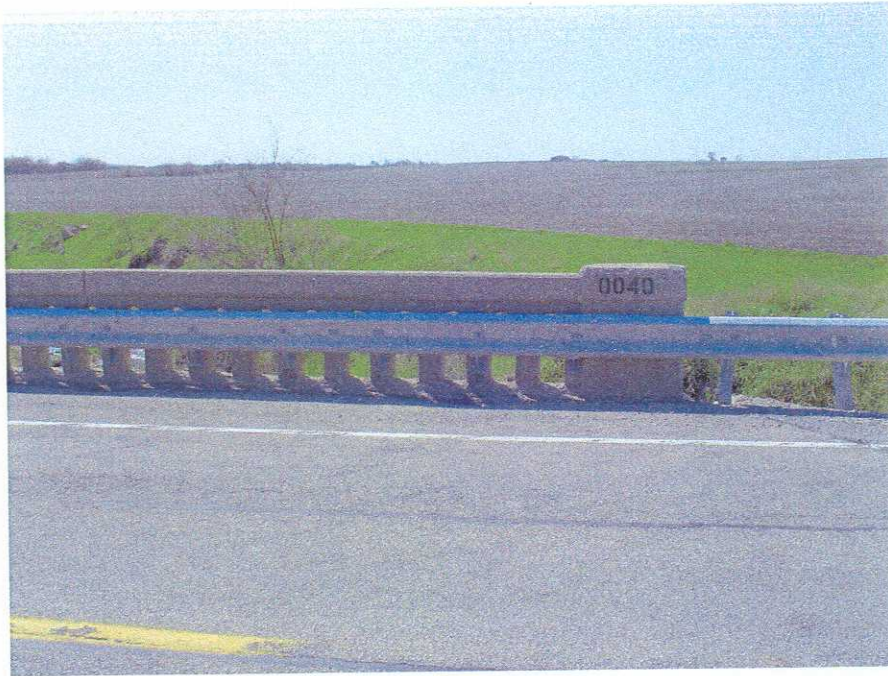
NORTH END OF WEST BRIDGE RAIL

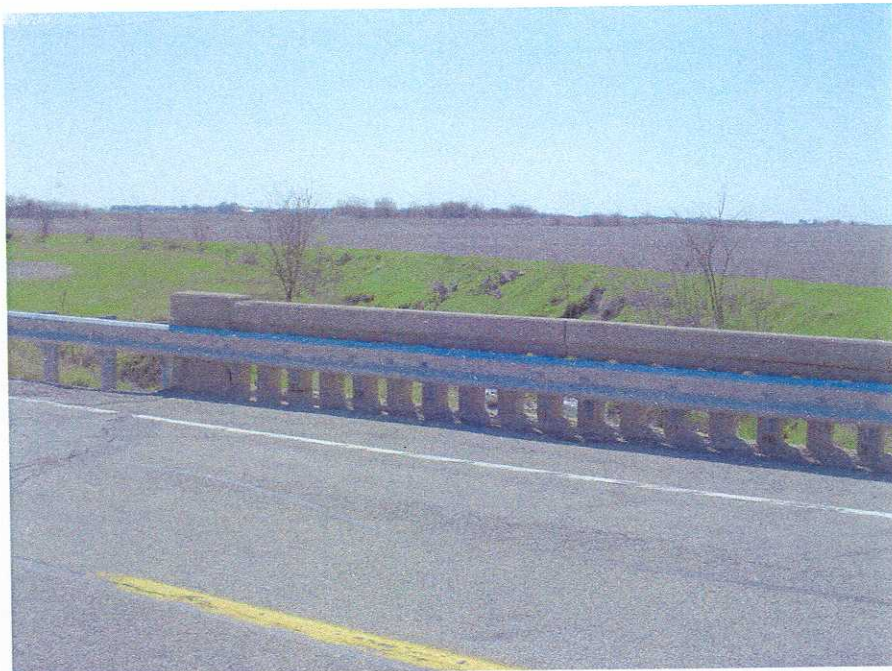
SOUTH END OF WEST BRIDGE RAIL

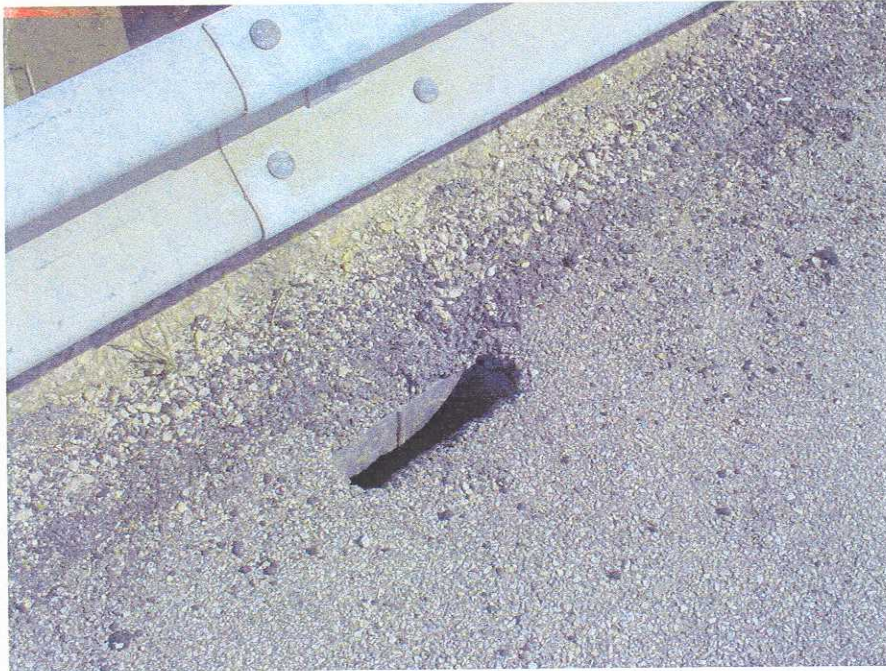
TYPICAL DECK DRAIN

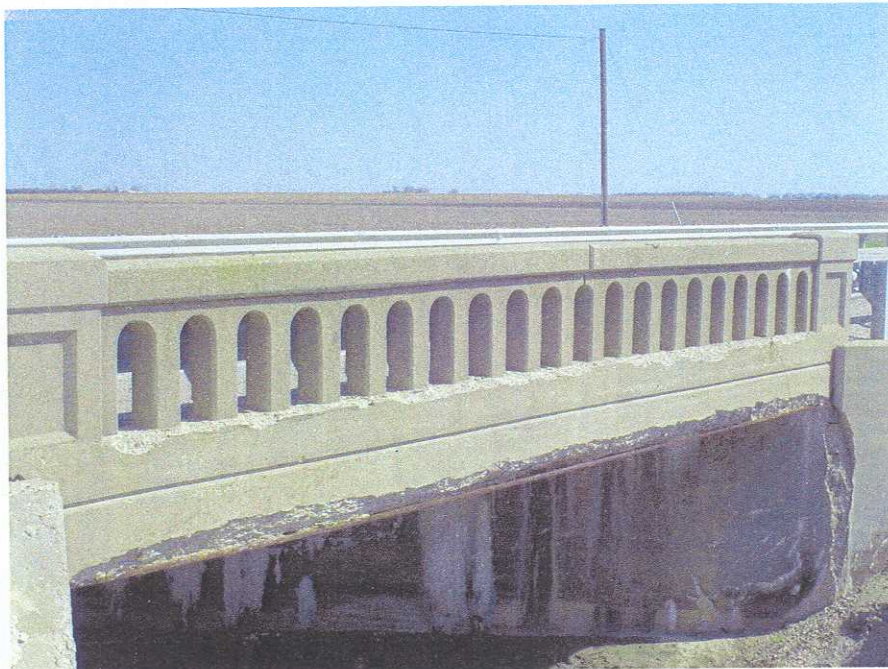
WEST FASCIA

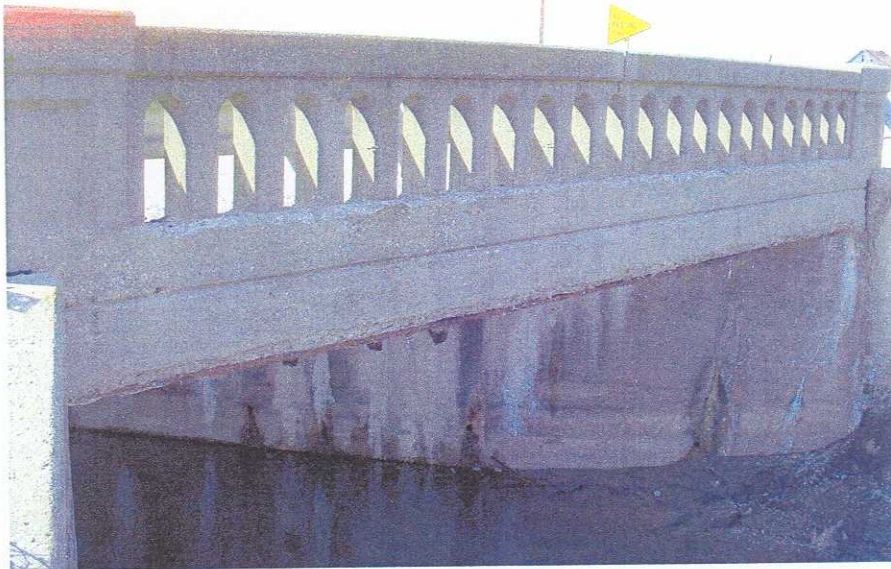
EAST FASCIA

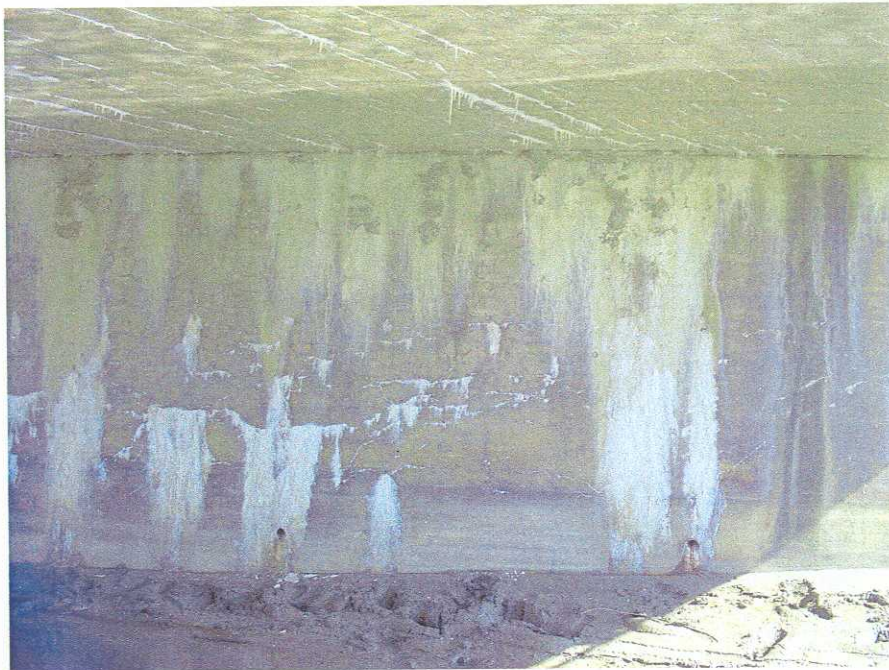
SOUTH ABUTMENT (center section) (2 of 3)

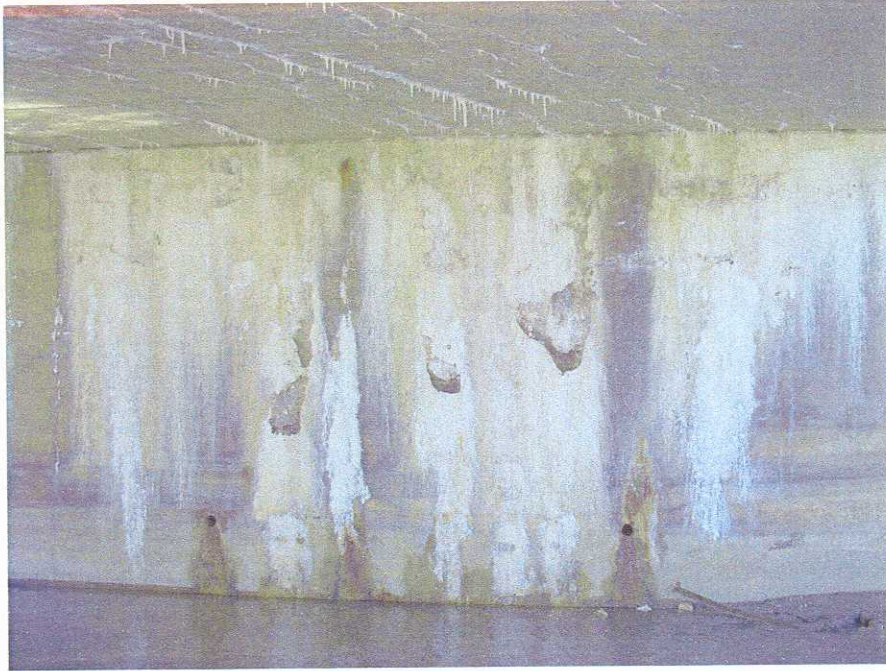
NORTH ABUTMENT (center section) (2 of 3)

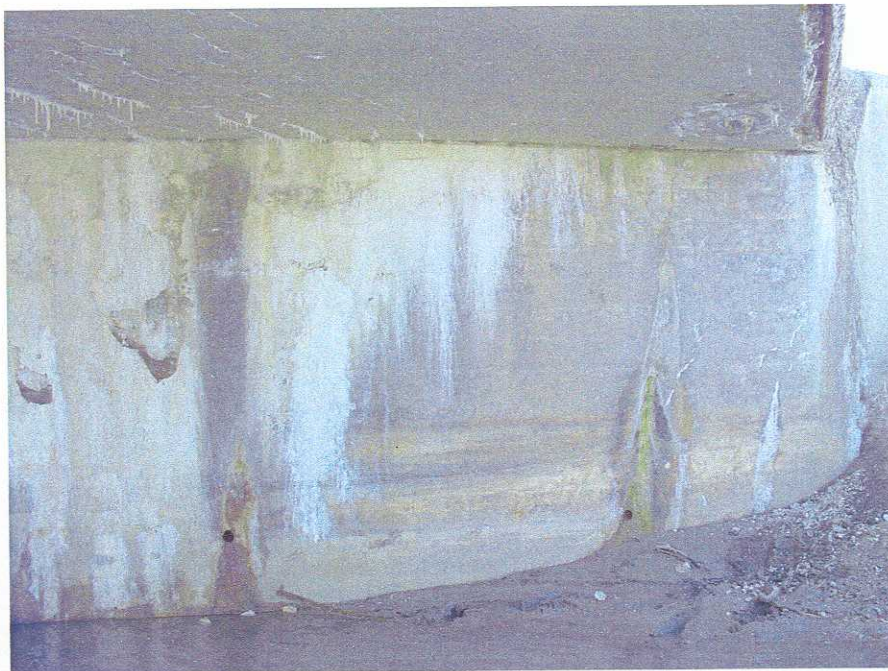
NORTH ABUTMENT (east section) (3 of 3)

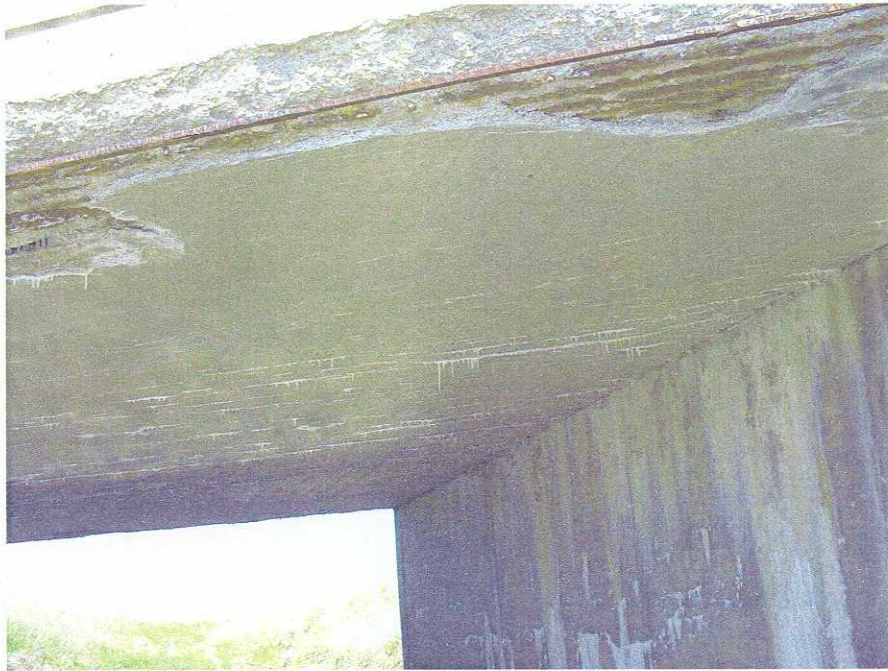
UNDERDECK (south end) (looking east)

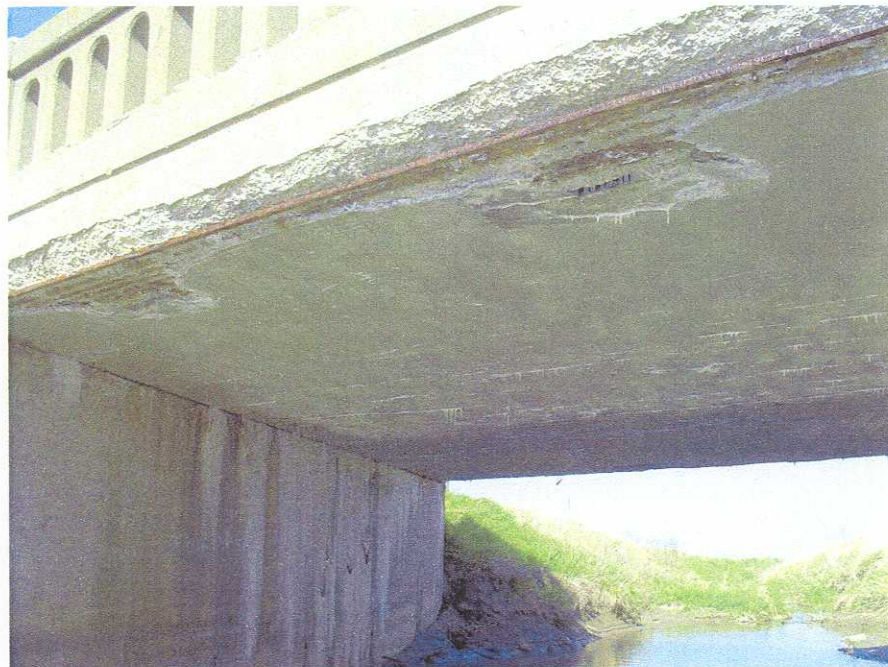
UNDERDECK (north end) (looking east)

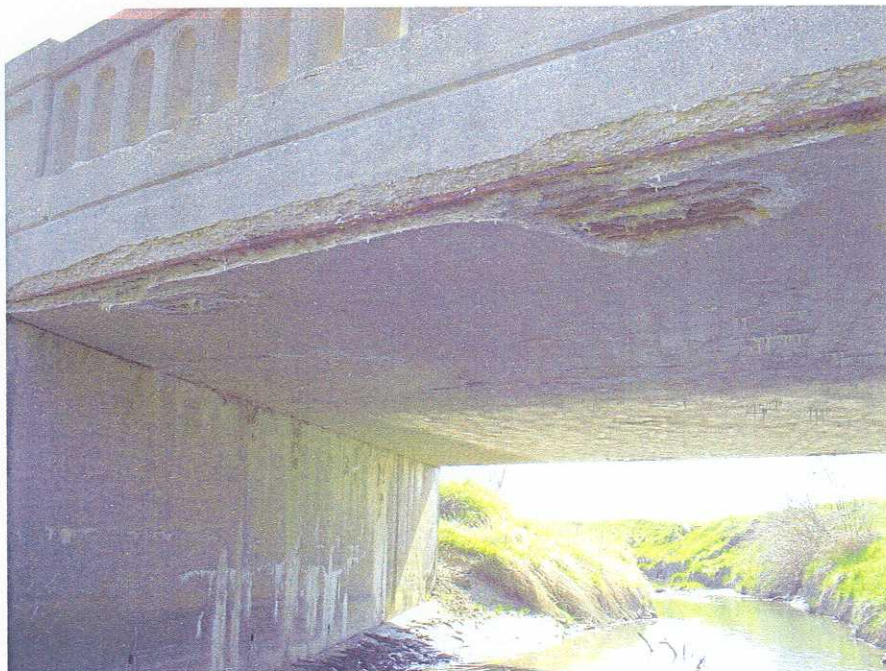
UNDERDECK (south end) (looking west)

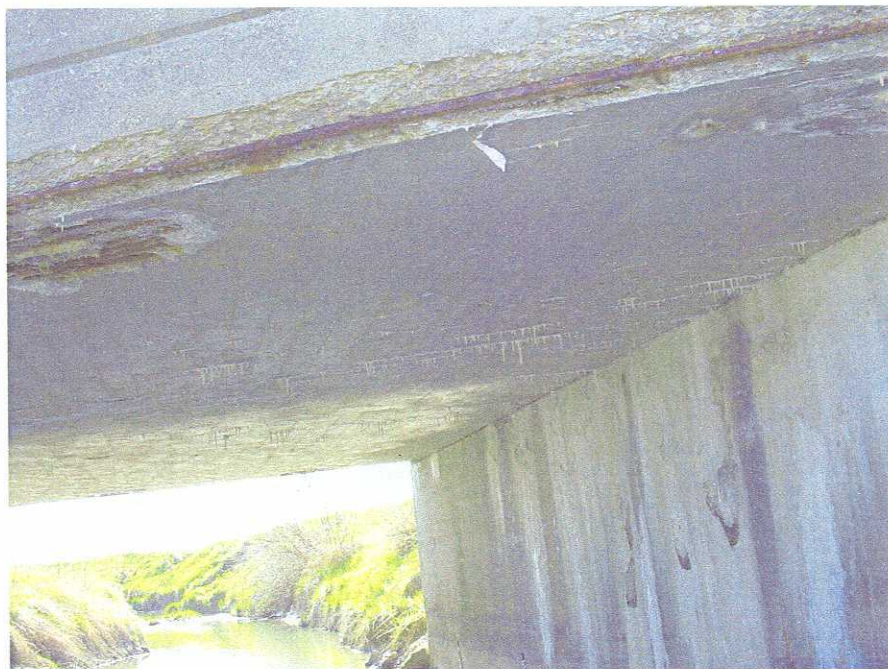
UNDERDECK (north end) (looking west)

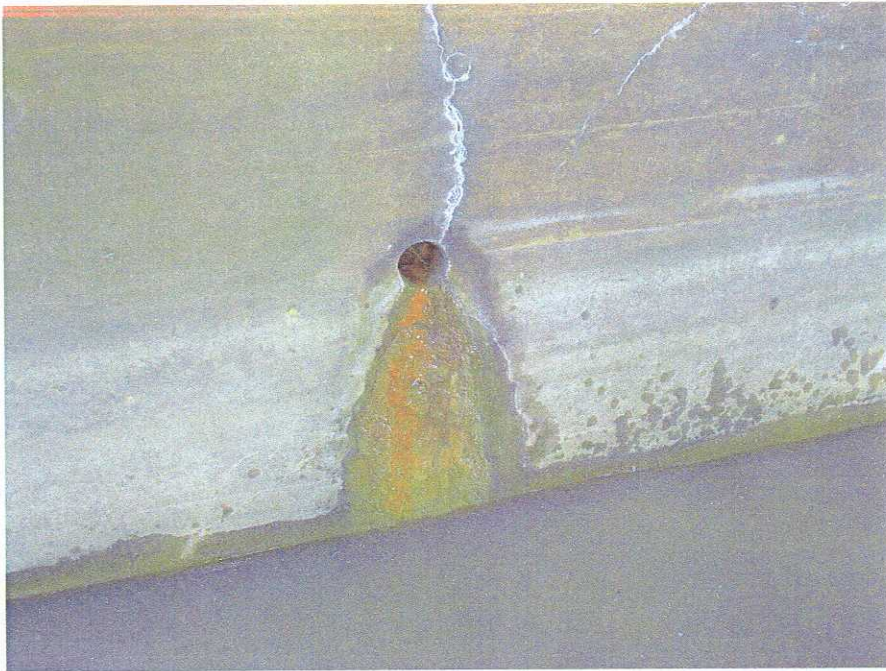
TYPICAL WEEP HOLE
